CIVIL AERONAUTICS BOARD

AIRCRAFT ACCIDENT REPORT

TRANS WORLD AIRLINES, INC., LOCKHEED CONSTELLATION L-1049H, N 102R,
MIDWAY AIRPORT, CHICAGO, ILLINOIS, NOVEMBER 24, 1959

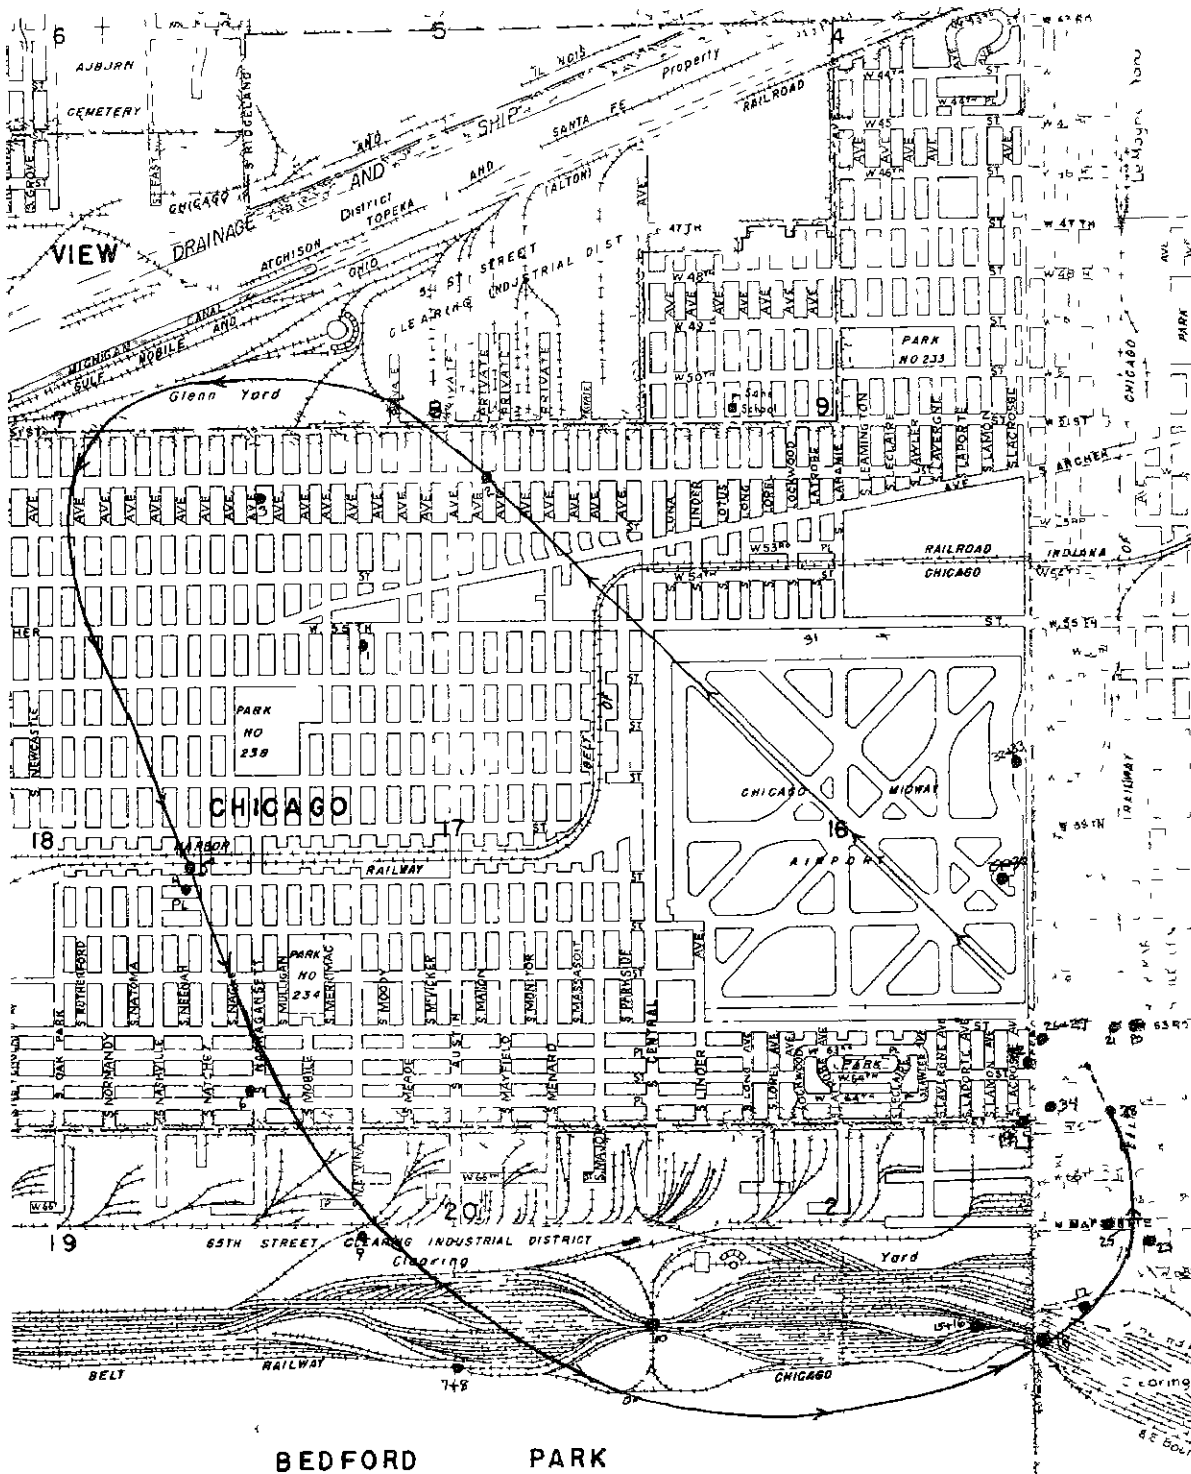
Attachment I

The total distance Flight 595 traveled over the ground from the beginning of its takeoff roll to the point of impact was about eight statute miles. This flightpath was elliptical in shape and at no time was the aircraft more than two miles from the airport.* Ground observers all stated that their view of the aircraft was never obstructed by clouds.

APPROXIMATION OF PROBABLE FLIGHT PATH AS DERIVED FROM WITNESS STATEMENTS
