National Register of Historic Places
Inventory—Nomination Form

historic AS SOMBORU PILLBOX II
Japanese World War II fortification

historic name: AS SOMBRERO PILLBOX II (66-01-1203)

Tumon Beach Pillbox, Tumon Bay, Guam

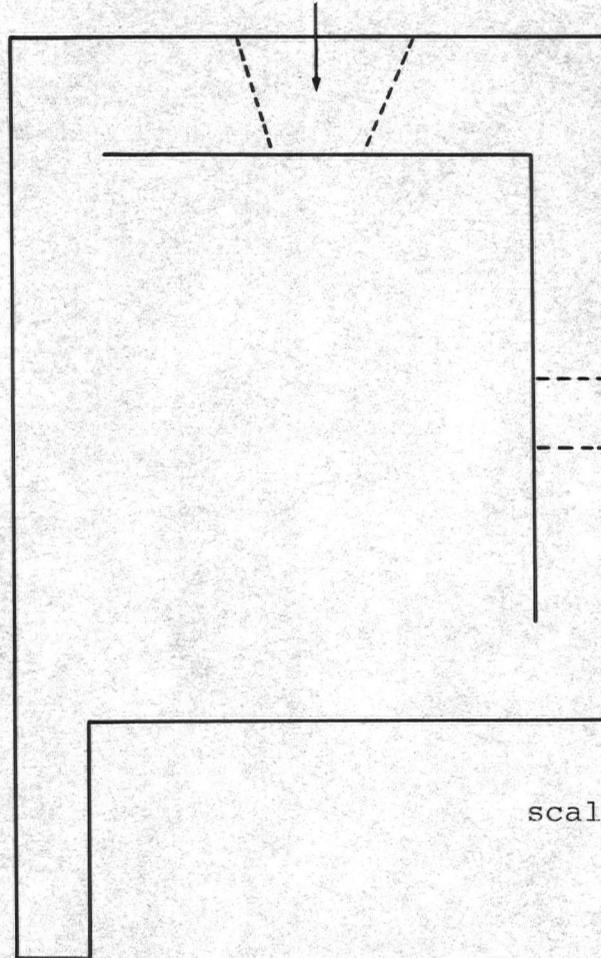
Plan view

embrasure

scale: 1cm = 30cm

The pillbox measures about 2.40m by 2.70m. The west wall of the structure extends 1.0m beyond the rear, probably to provide extended protection to the entrance which is presently obscured. The extended wall is .30m thick. The north wall, which has a gun port with a view of the northeast portion of Tumon Bay, is .50m thick. The exterior opening of the embrasure measures .70m by .26m. The east wall, which is .30m thick, has a window with a view of the landward side of the structure. A previous drawing shows an air vent in the south wall. It is likely that the east and south walls are also .30m thick. Horizontal impressions of the boards used to construct the form into which the concrete was poured are apparent on the exterior surface of the structure.

Previous documentation indicates that the roof is .45m thick. The top of the roof is 1.25m above present ground surface. The roof is flat. A row of coral rocks has been cemented to the surface of the north edge of the roof above the embrasure.
